ELECTRONIC DIAGNOSTICS!

Part 8: Chris Graham investigates Ford's EEC-IV management system as found on the Granada 2.9i.

ENGINE MANAGEMENT

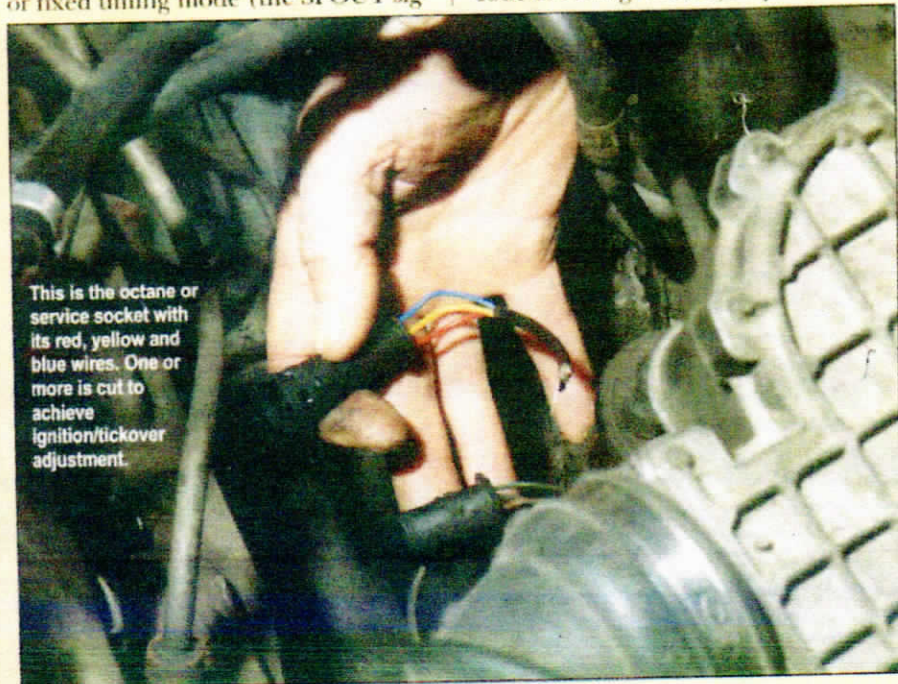
This is the octane or service socket with its red, yellow and blue wires. One or more is cut to achieve ignition/tickover adjustment.

Frank says that confusion often arises concerning ignition and mixture adjustments and he offers the following advice. The octane service socket, which is located next to the coil, is a three-wire (red, blue and yellow stripe) device and must be disconnected from the ECU for all tune-up procedures.

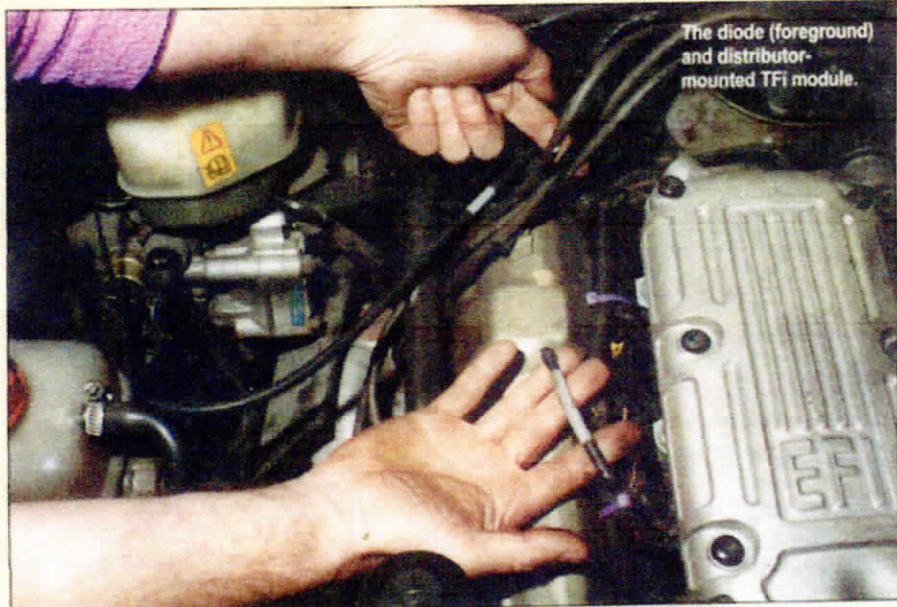
The diode (foreground) and distributor-mounted TFI module.

A distributor is fitted at the back of the engine and features a Hall effect trigger (square wave output), mounted on which is the TFi module named after its manufacturing process - Thick Film Integration. This controls the primary coil switching (dwell). The Hall signal output to the TFi provides the PIP (Profile Ignition Pick-up), crankshaft speed and position information and is then sent to the EEC-IV module. Here it is modified with reference

checked with an ohms meter across the diode which will show infinity (a block) one way and a resistance reading the other. This is the correct condition.

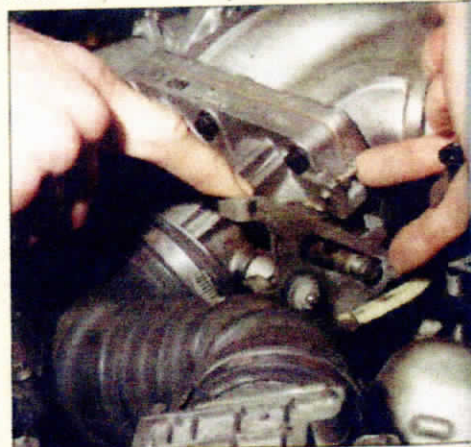
The throttle stop and roller bearing linkage are important factors when tuning this engine.

Make sure that the throttle stop is adjusted correctly so that the throttle discs

are not fouling the body. The stop is often wrongly used to provide idle adjustment. Carefully check the throttle potentiometer voltage. This is a five-volt component and has an output which should range from 0.6-4.5V in a very smooth, linear transition. It is not adjustable so, if the reading is incorrect, then it's probably the throttle stop which is at fault (driving the voltage too high). If the voltage is wrong but the stop setting is OK then the throttle pot. is at fault and this is a common failure. Check supply and earth also.

The throttle stop must be set correctly and the voltage output of the throttle potentiometer measured with an accurate voltmeter. The base output of the latter must be no greater than 0.8V; higher values will cause the ECU to disconnect the idle control valve which is bad news. Washing out the idle control valve will normally cure most problems but in some cases it may have to be replaced.
