# MIDDLEBRIDGE POWER STEERING OVERVIEW

## **Power Steering Rack**

## **Power Steering Pump**

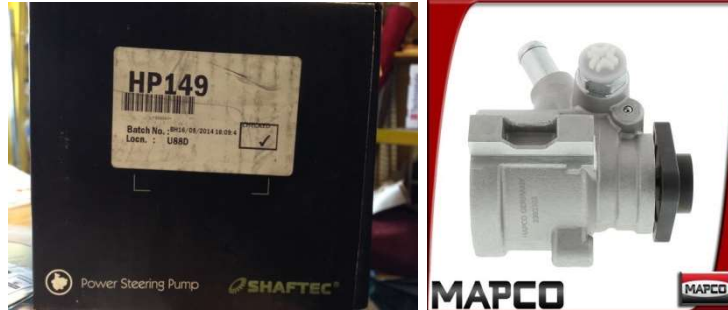
Ford Power Steering Pumps no longer available.  
Alternative Mapco shown.

**Pump Hyd. Res:** Possibly: Fiesta MK2 or Sierra Cosworth (Pt No. 88GB-3R700-AD).
